BRITISH COLUMBIA EARTHQUAKE

June 23, 1946

By ERNEST A. HODGSON

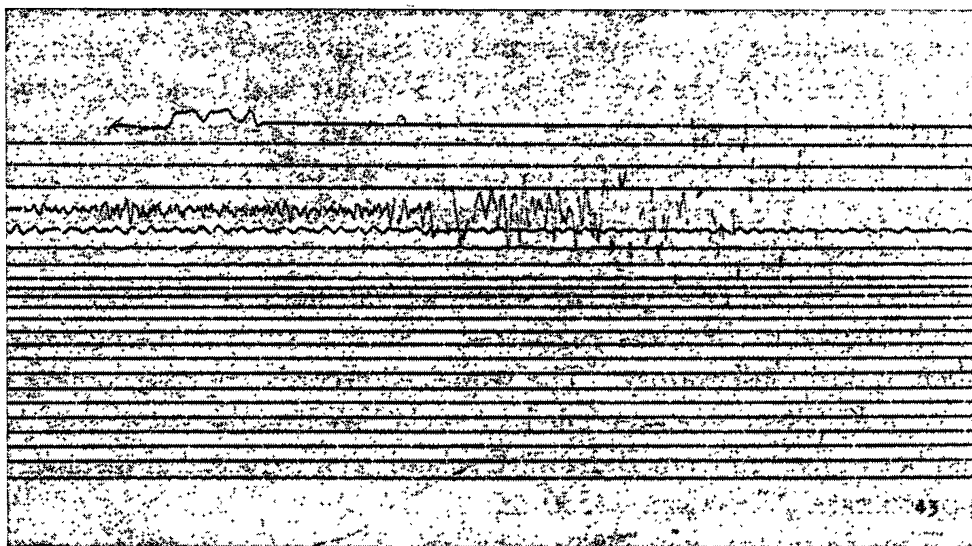
Fig. 43. Section of Milne-Shaw Seismogram, NS-Component, Ottawa.

An excellent record of the earthquake was registered on the seismographs at Ottawa (Fig. 43). It was at once established that the origin time of the shock was about 17^h 13^m 19^s U.T. (10^h 13^m 19^s a.m., P.D.T.), and that the distance from the epicentre to Ottawa was about 3700 km. (2300 mi.). This would define a circular arc, with its centre at Ottawa and a radius of 3700 km. The arc crosses Vancouver Id. from about Barkley Sound to Campbell River. It is to be noted that these first readings are only approximations, since the records from all stations should be considered together when making a final determination.

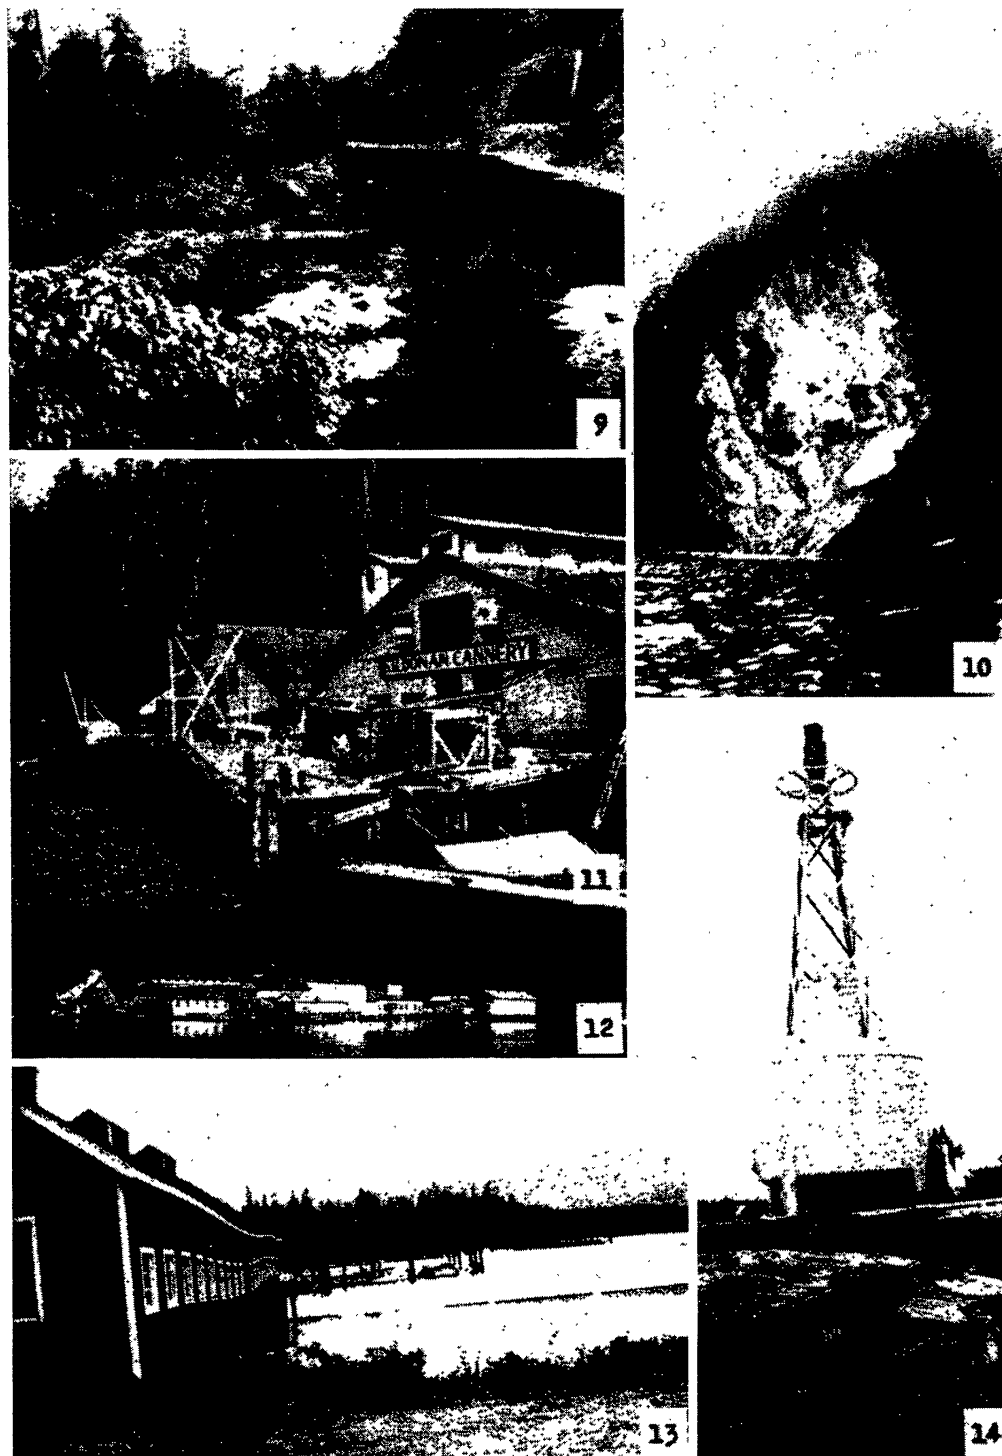
Fig. 10. Rockslide, Henderson Lake (Photo. A. P. Larsen).

Fig. 11. Damaged Wharf, Kildonan Cannery (Photo. B.C. Packers).

Fig. 13. Damaged Net Loft, Deep Bay Cannery (Photo. B.C. Packers).

At the B.C. Packers' plant at Kildonan on Uchucklicit Inlet, damage officially estimated as from \$25,000 to \$30,000 was caused by the earthquake. It is believed that this was due simply to the

At the time, ice was being crushed for shipping fresh salmon. An ice plant at Kildonan supplies this refrigerant in large quantities. The crusher was operating on the wharf. When the slump occurred, the machine fell into the water, carrying the operator. He was unable to swim and, with a broken shoulder, was in some danger. He was rescued and sent to Alberni hospital.

The major part of the damage occurred in the cannery. This was not in operation at the time, but the machinery was broken or thrown out of alignment. Most of the expense involved was concerned with putting this equipment into operation again. The damage here was reported in detail to his Company by Mr. DeGraves, who furnished a copy, which has been largely drawn upon in this report.

It seems safe to assume that the damage at Kildonan was the result of the slip-off of the alluvial fan. On the other hand, serious landslides occurred in this vicinity which indicate that the shock was intrinsically severe (Fig. 10). It would be most valuable could changes in depth be determined in Barkley Sound, Alberni Canal and Uchucklicit Inlet.

A net loft, built on the south side of the spit, rests on piles which stand in water at high tide and are almost all uncovered at low tide. Around each of these piles there appeared sand blows. Some of the piles were pushed up, some were sucked down, (as indicated by barnacles on the piles), with the result that the net loft was badly distorted as shown in Fig. 13. The distortion there shown was all caused by the earthquake.

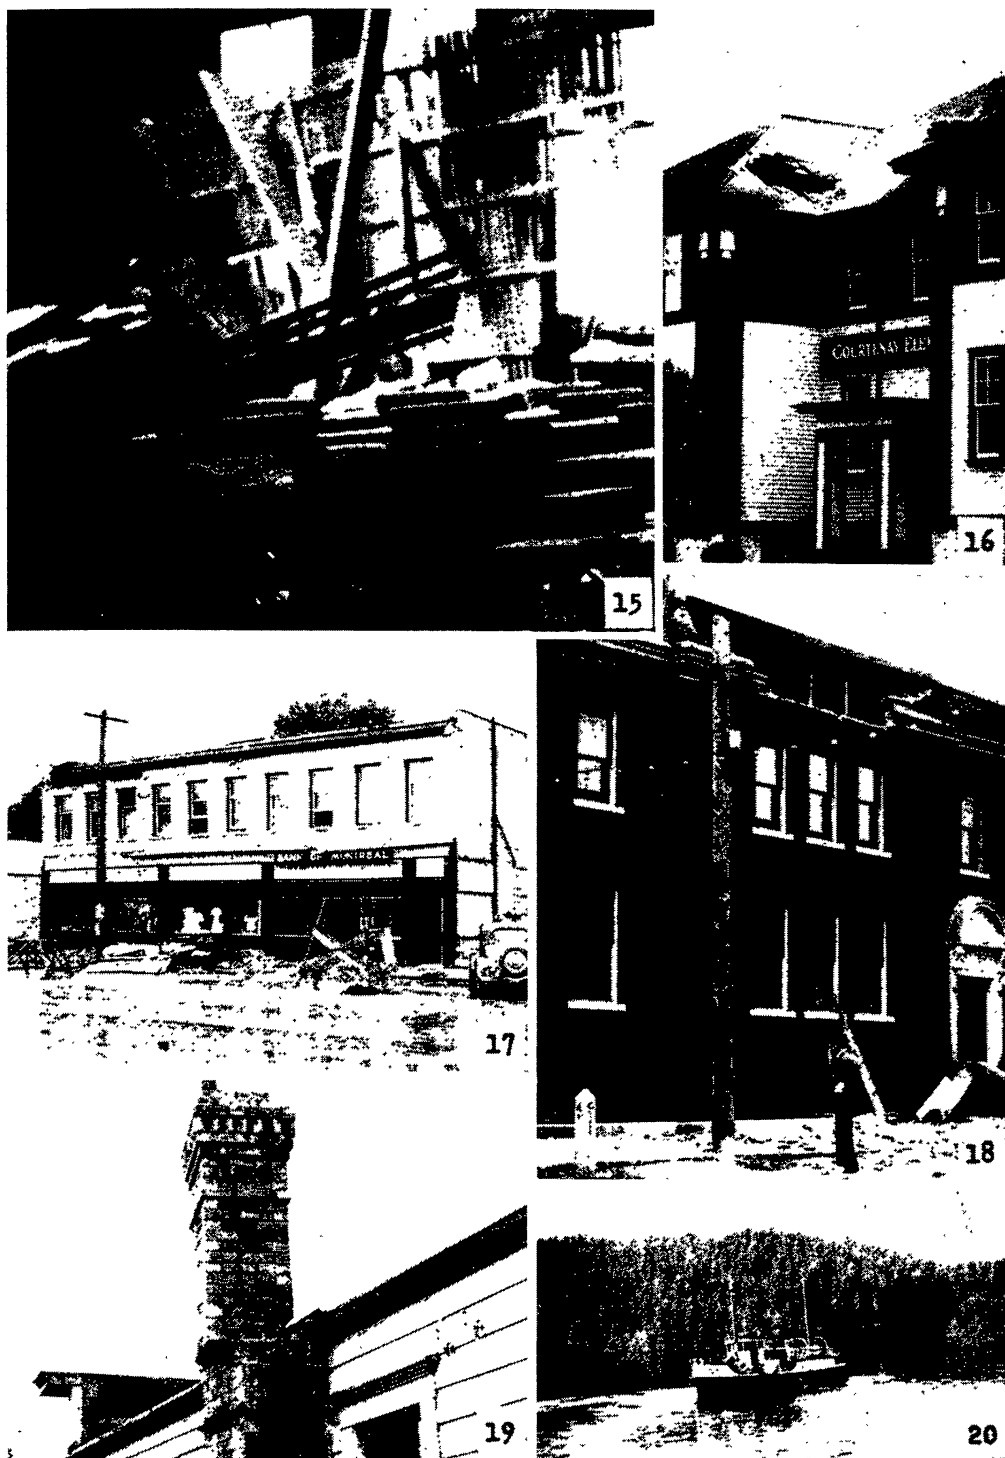
Fig. 15. Damaged Class Room, Courtenay Elementary School
(Photo. Silvertone).

Fig. 16. Fallen Chimney, Courtenay Elementary School (Photo. Silvertone).

Fig. 17. Damaged "Motion Block", Alberni.

Fig. 18. Damaged Post Office, Courtenay (Photo. Silvertone).

The tower of the post office was damaged by the heavy clockwork shifting in its anchorage. The front of the building was barricaded and business continued as usual, entrance being gained through a rear door. A rotated chimney in Port Alberni is shown in Fig. 19.

The "Motion Block" in this town was damaged as shown in Fig. 17. This received a good deal of newspaper publicity but was not very important as earthquake evidence. A flat roof on a brick veneer structure, none too well built and on deep ground, shifted back and forth, knocking several of the top courses of brick into the street. No one was injured.

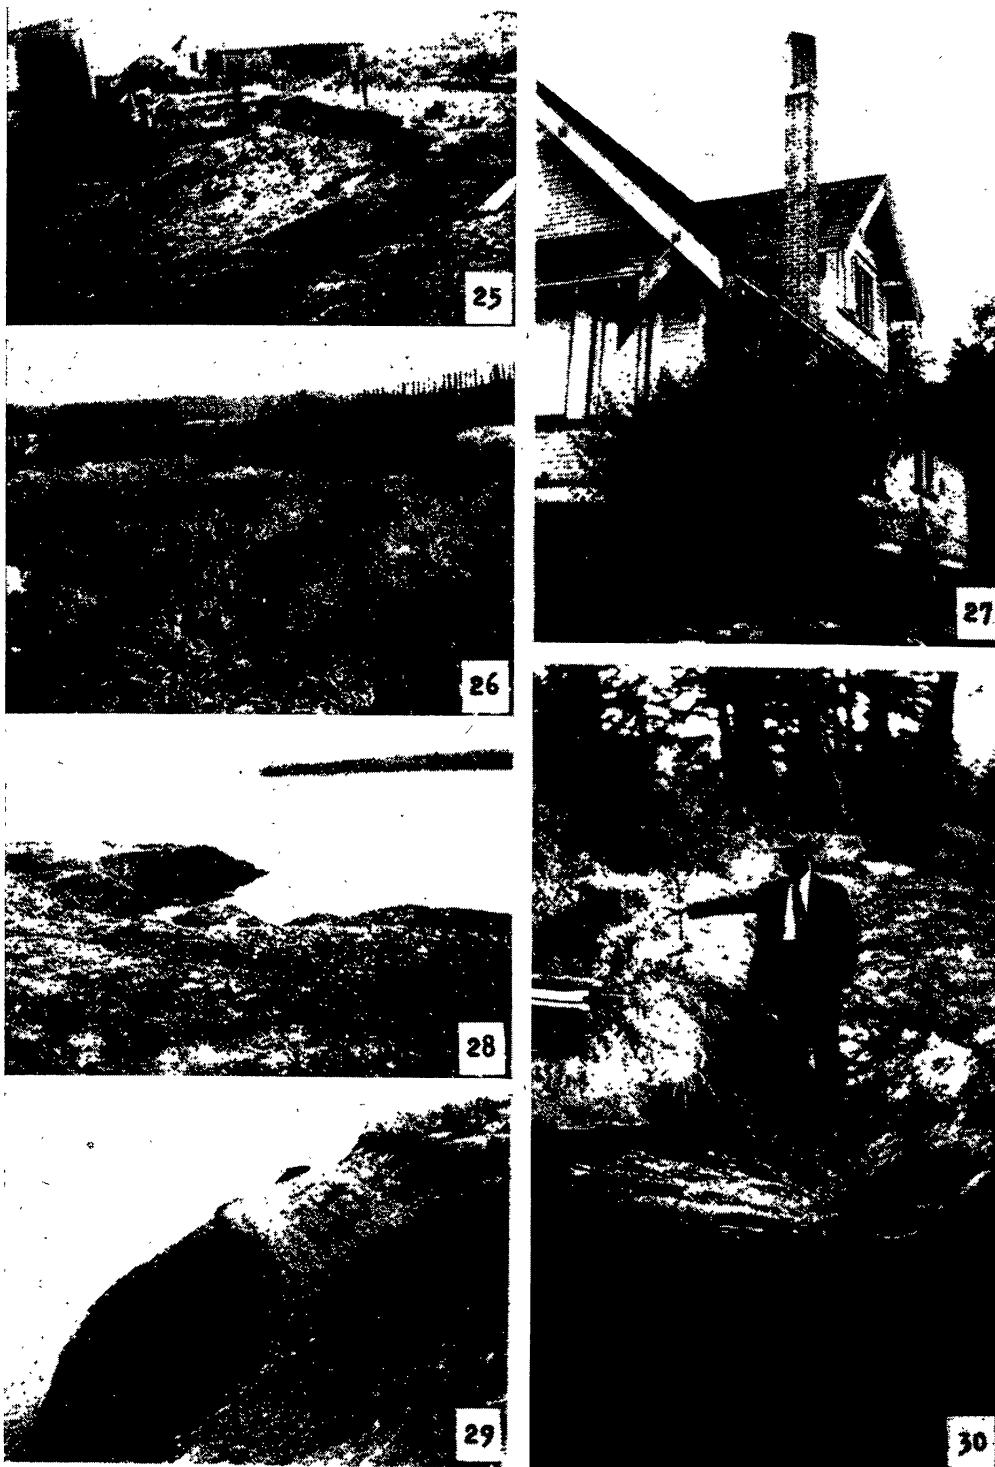
Fig. 25. Sunken Trough, Maple Guard Spit (Photo. B.C. Packers).

Fig. 26. Sunken Trough, Maple Guard Spit (Photo. B.C. Packers).

Fig. 30. Sunken Trench and Sand Blow, with Mr. DeGraves, Rebecca Spit.

Where the water at the north side of the spit was only two to five feet deep at high tide on a shelving beach, it is now a hundred feet deep. A deep bay encroaches on this side as shown in Fig. 5. Indentations in the beach (Fig. 28) indicate the extensions under water of down-dropped trenches on the spit (Figs. 25, 26). In places these trenches on the land reach a depth of five feet. It is to be noted that the trenches and depressions are not caused by the slump to the

The largest one crosses the spit in a north-south direction as an extension of the "depression" shown in Fig. 5. In places on the spit are craters several feet in diameter, some in the trenches, some on ground otherwise not marked by cracks. They are referred to as "sand blows." At the time of the earthquake, geysers of water, forced up under pressure, carried sand, mud and sea shells to heights estimated by various observers as about thirty feet. They are reported all along the coast, on the land and in the water from Deep Bay to points above Campbell River. On June 27, Mr. DeGraves was unable to reach bottom with a twelve-foot pole in some of the larger ones on Maple Guard Spit. By July 8, the elevated craters on this spit had become saucer-like depressions, some three feet in diameter and a foot or more deep.
